Case Study

The Challenge

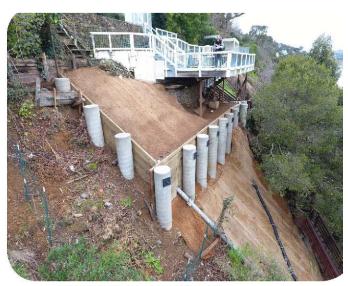
Restored Hillside

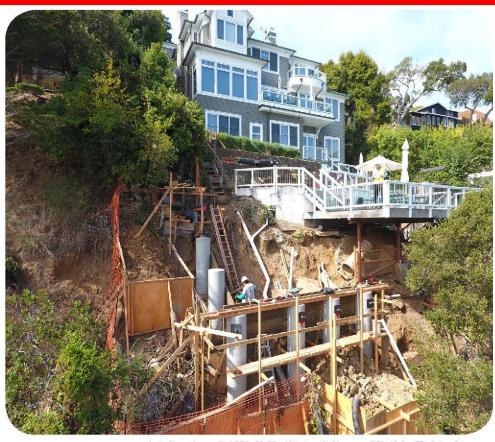
1st Section Of Wall Built And Scarp Visible Behind

extremely limited access, it was decided that the best approach was to use RWR's portable drilling equipment to construct a retention system consisting of 24" diameter drilled piers extending above grade into cast concrete columns. The columns were restrained at the top with 1" diameter double corrosion protected

tiebacks grouted in 6" diameter drilled shafts. After casting of the 24" diameter columns and installation of the tiebacks, 6" x 12".6 ACZA pressure treated timbers were installed for lagging, then a sub-drain system consisting of perforated pipe and class II permeable drain rock was placed behind the lagging. The hillside was then rebuilt by bringing back up the slide soils from below and placing them in compacted lifts behind the new wall system. The tiebacks were initially lighted loaded so as not to pull the columns out of plumb. After all backfill was placed, the tiebacks were proof tested and locked off at full design load. A new surface drainage system was installed to collect rain runoff over the entire repair area, the access stairs to the dock were jacked back onto and reconnected to their foundations and all damage to the stairs was repaired. Lastly, all disturbed areas were seeded then covered with a layer of erosion control blanket and galvanized steel chain link netting anchored to the new piers.

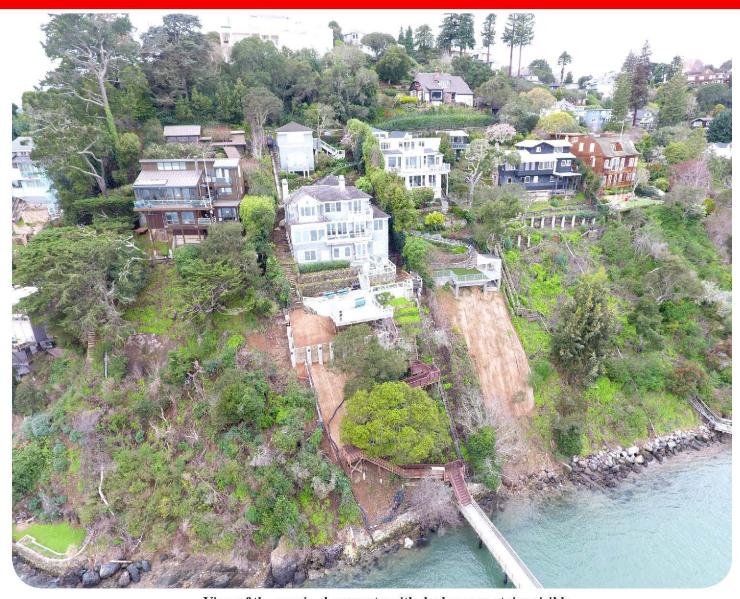
View of the repaired property with dock access stairs visible
