### Earthquake retrofit: Multi-story Hotel, San Francisco

#### The Challenge

This hotel was built on unstable fill and sands and was in danger of collapse in the event of a severe earthquake. A structural analysis showed that the inner core of the building needed to be reinforced with shear walls and underpinned with cast-in-place reinforced concrete piers.

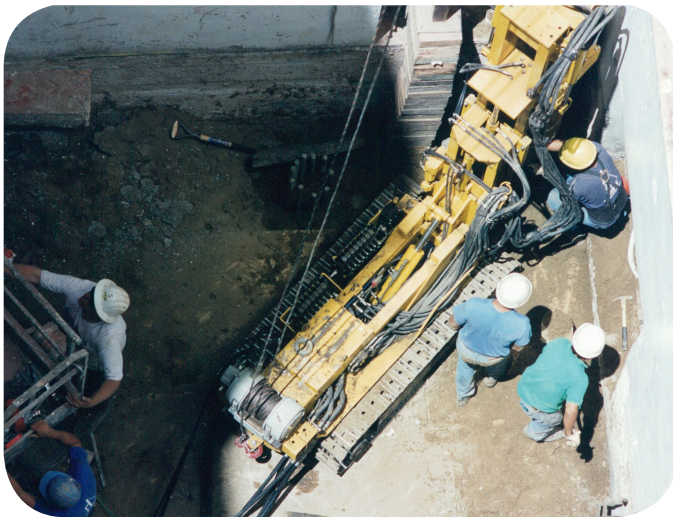
Overhead shot of pier drilling  
in corner of courtyard

A small track rig was used that fit through the narrow opening. Groups of 4 piers 40 ft. deep were placed in each of the 4 corners. 18" diameter continuous flight augers and steel casing were used for the pier drilling.

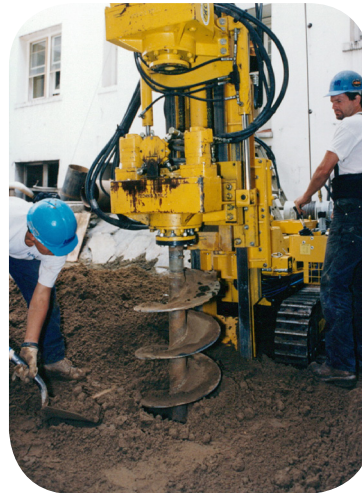
Starting a new pier hole  
before inserting casing

The inner courtyard was inaccessible except for an 8 ft. tall x 5 ft. wide opening. The height of the building prevented the use of cranes to place equipment or material into the courtyard. Furthermore, since the soils were noncohesive, all piers had to be cased for the top 25 ft.

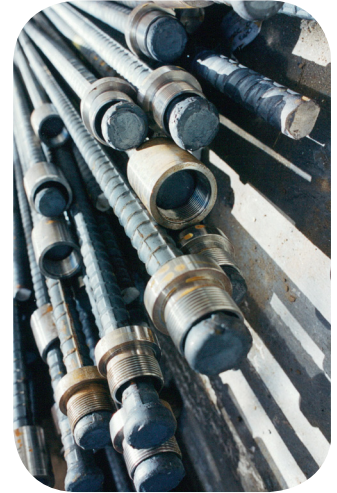
Detail showing  
rebar couplings

The cages were winched through the opening in sections and then assembled to full length with rebar couplers. They were then raised over the piers and lowered in using temporary tube steel pole and winch systems bolted to the sides of the building. The piers were then poured as the casing was retracted.

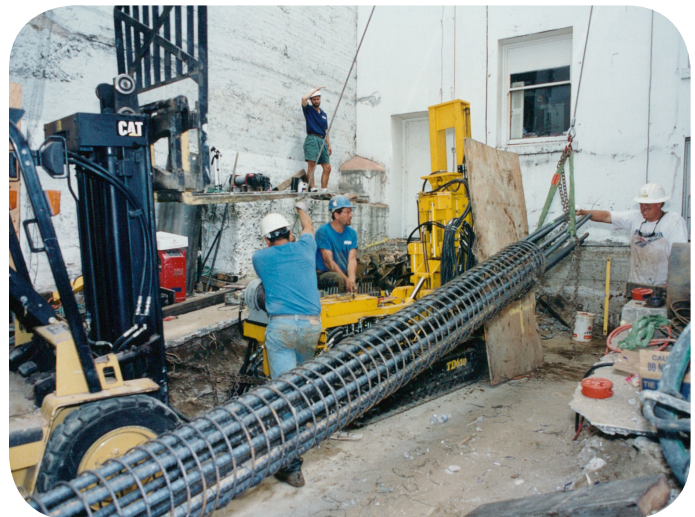
Raising a reinforcing cage  
consisting of #8 rebar and spiral ties

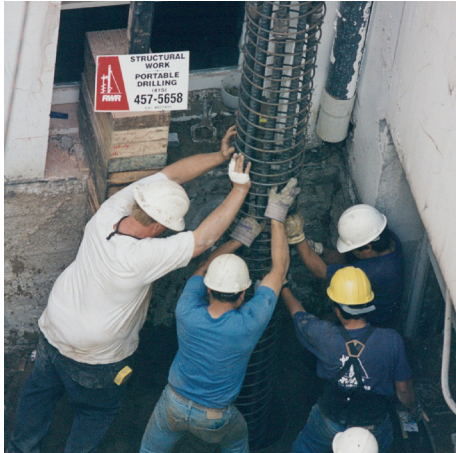
**Placing a reinforcing cage into a pier hole in the corner**

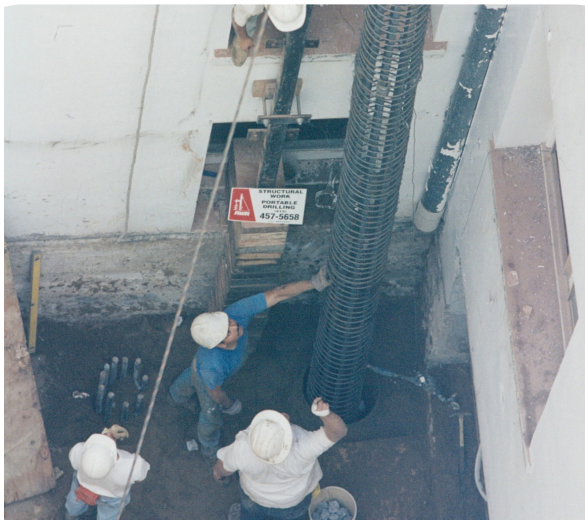
**Lowering a cage down into a pier hole with the temporary winch system**

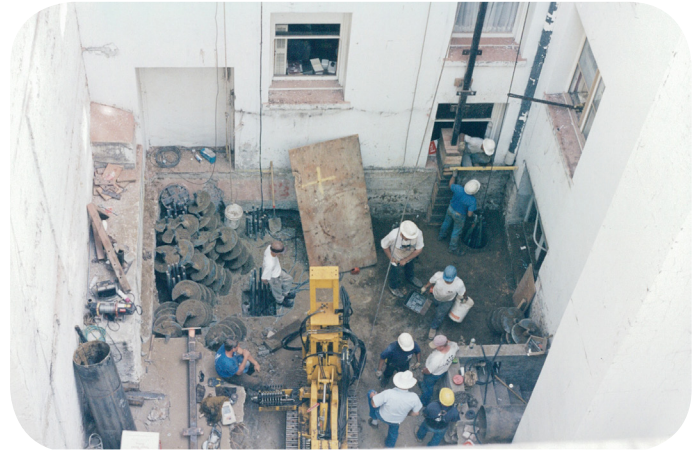
**Overview of construction site showing continuous flight augers and one set of completed piers at upper left corner.**

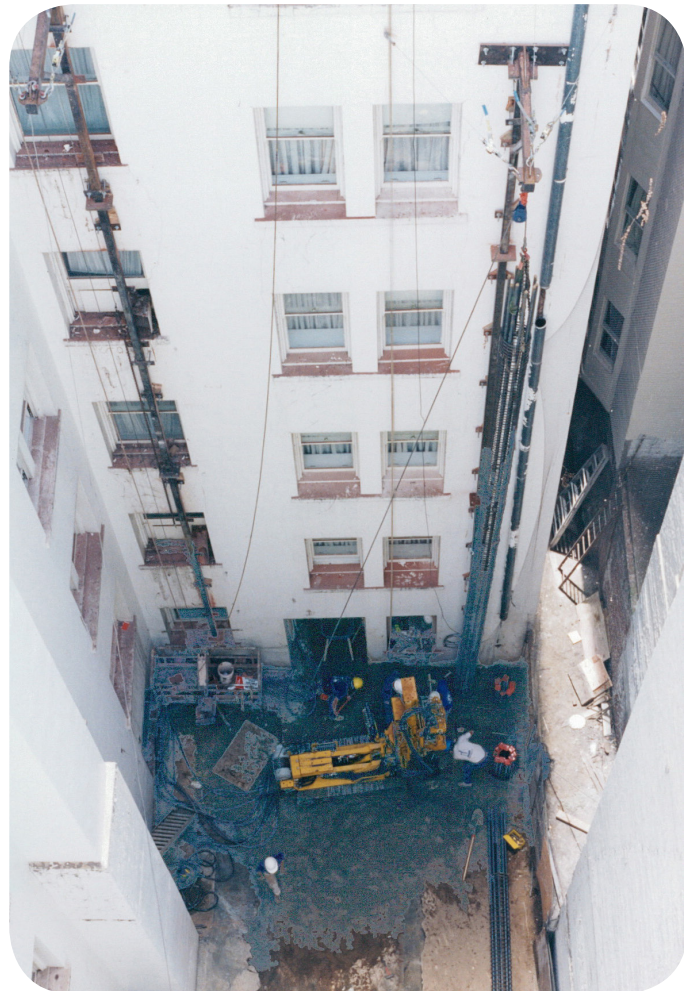
**Picture showing temporary winch systems bolted to building and suspended cage at right side. Access opening visible at center bottom.**
