### Earth Stabilization Project Santa Rosa

#### The Challenge

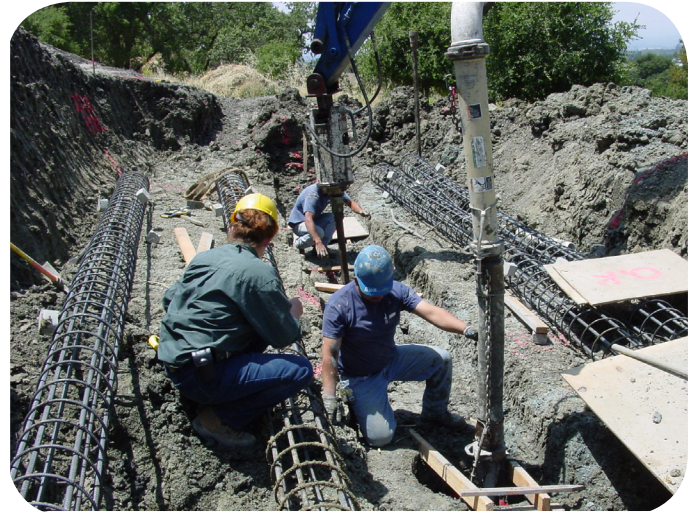
Inspector watching tremieing operations  
with drilling going on in rear

The repair plan for the front of the complex called for a tiered installation of piers and grade beams to retain the below grade portion of the slide. Because of excessive underground water and caving, the piers had to be drilled, the reinforcing cages installed and concrete placed via tremie all in one continuous operation. Above grade, a series of gravity walls using interlocking masonry units, pins and geofabric were installed. The saturated soils had to be left out and turned in order to bring the moisture content down a level where 90% compaction could be achieved.

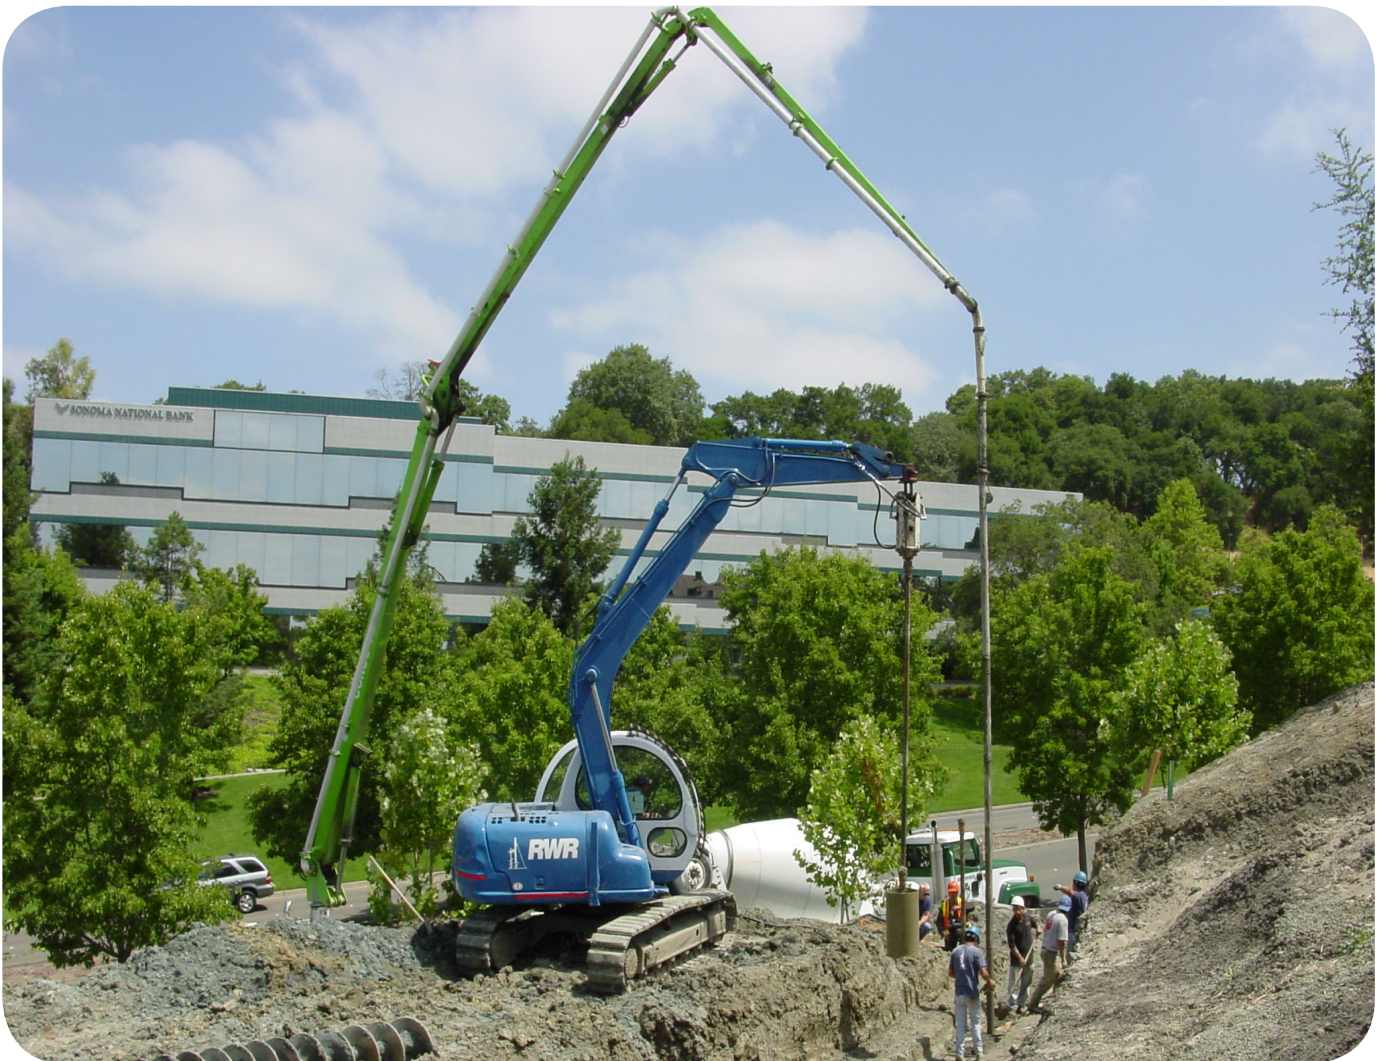
Continuous drilling and pouring operations.  
Note continuous flight auger on ground and core barrel on drill rig.

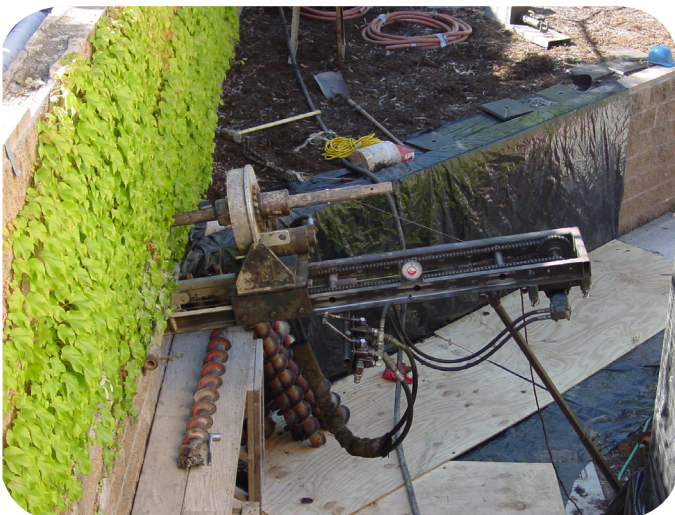
Tieback rig bolted to face of rear wall

The back wall was stabilized by excavating behind the wall and installing a drainage system to relieve hydrostatic pressure. Additionally, series of tiebacks with steel plates were installed at the face of the wall to prevent any further movement.

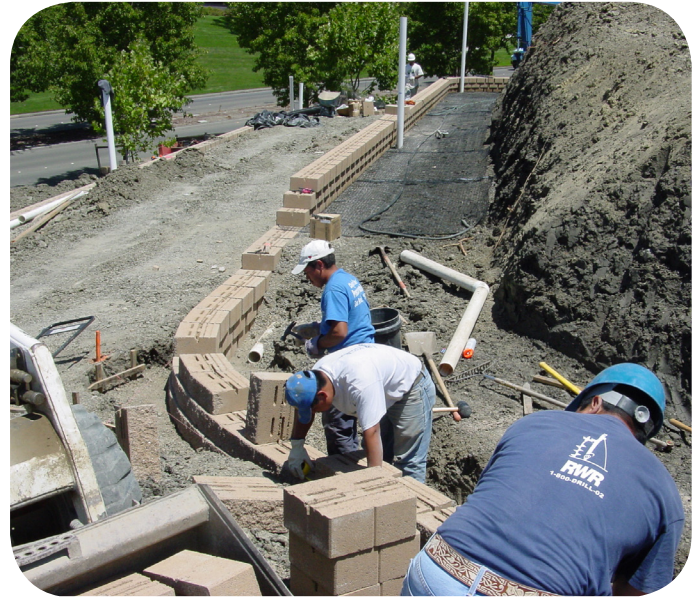
Constructing interlocking walls. Wall drain cleanout pipes sticking up in background

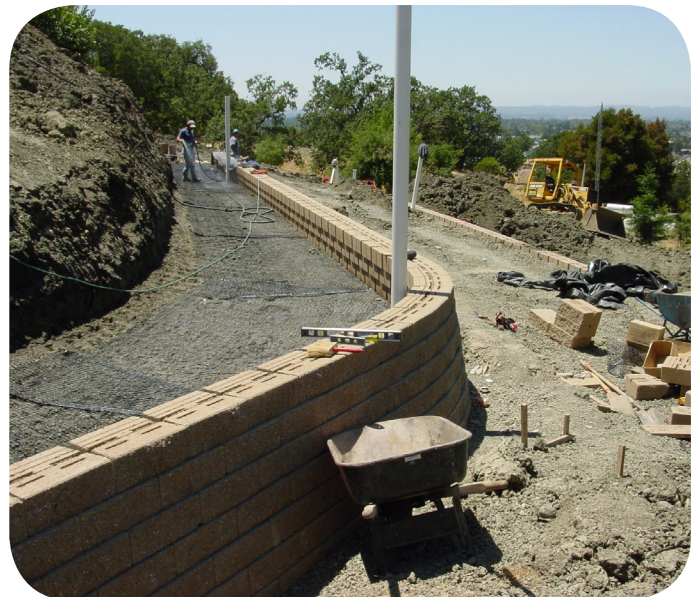
Partially completed interlocking wall with compacted native soils and drainrock behind
