## Foundation Improvement with Micropiles In San Francisco

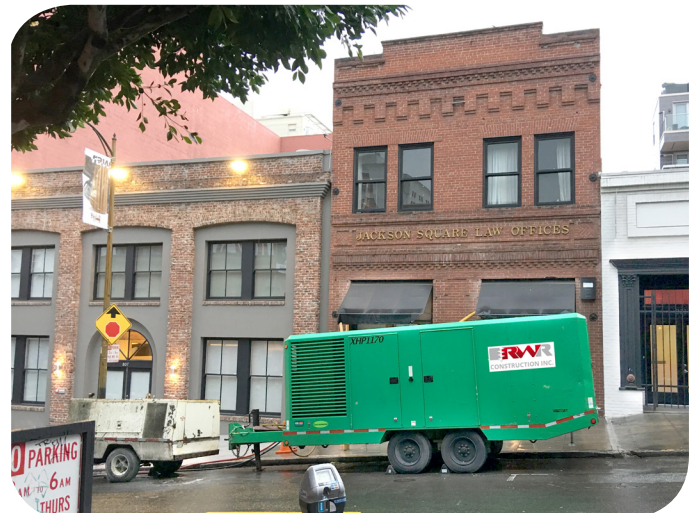
1050cfm high pressure compressor  
in front of job site

The drilling proceeded by advancing a retractable casing through the overburden until the tip was seated into the top the bedrock. A Down-The-Hole hammer was then advanced through the casing using 1050cfm of 350psi (high pressure) air to power the hammer and clear the cuttings. The DTH hammer continued to advance through the bedrock until the desired bond length was achieved.

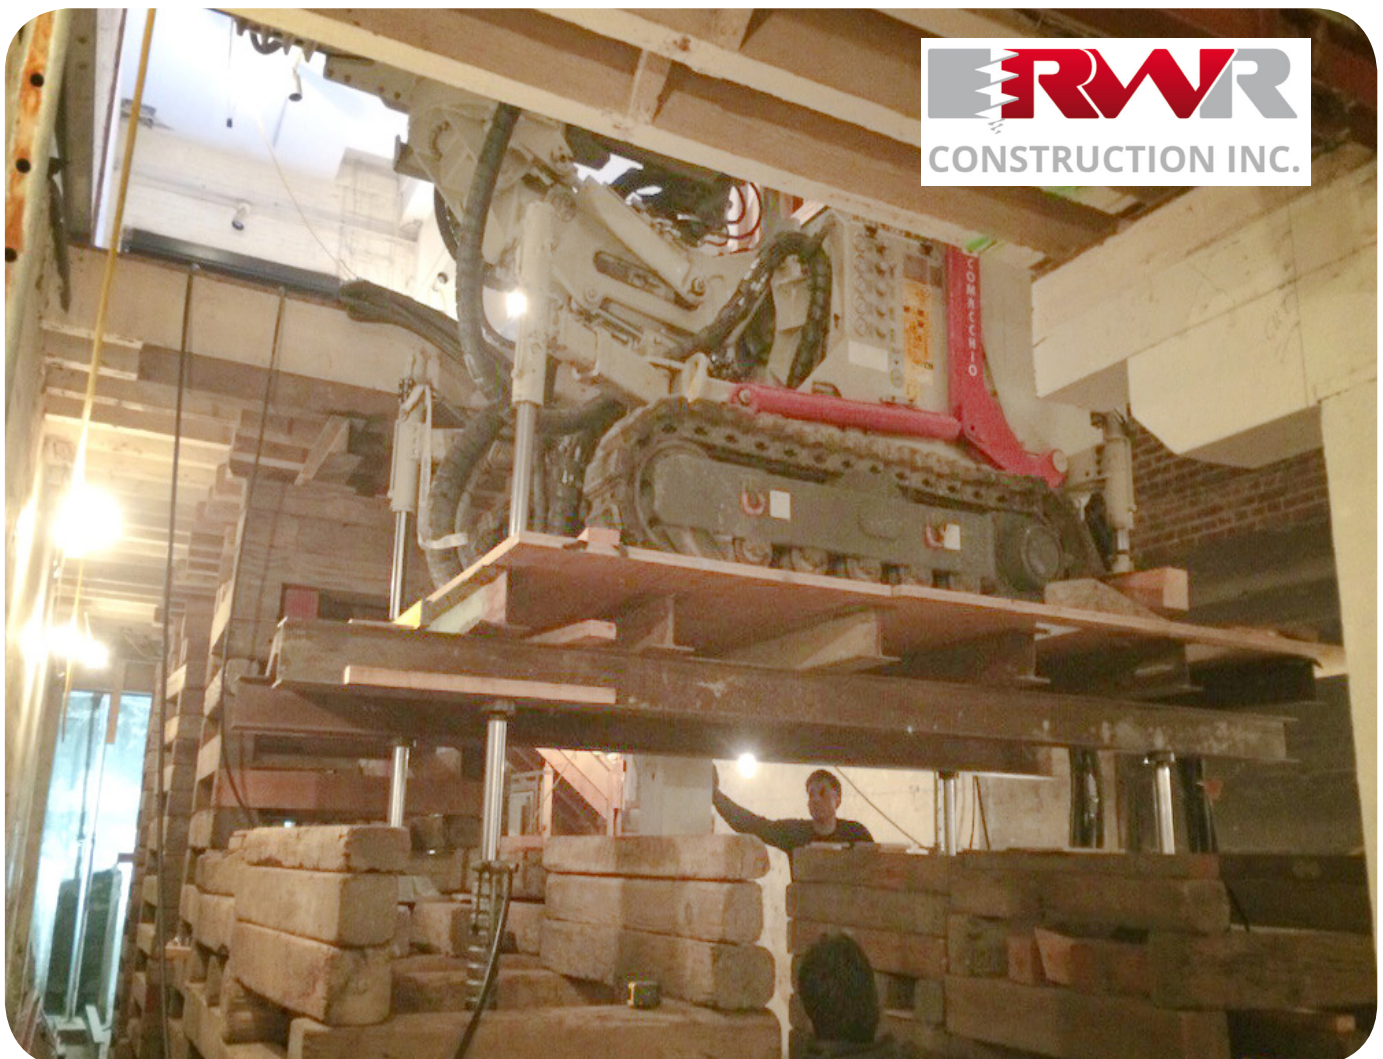
Drill rig being jacked down from mezzanine level to basement

To gain access, the front of the building was opened up at the street level and the floor was shored underneath from the basement. The drill rig was then tracked inside and onto a cribbed platform that went from the basement up through an opening in and level with the first floor. The rig was then slowly and carefully jacked down to the basement level.

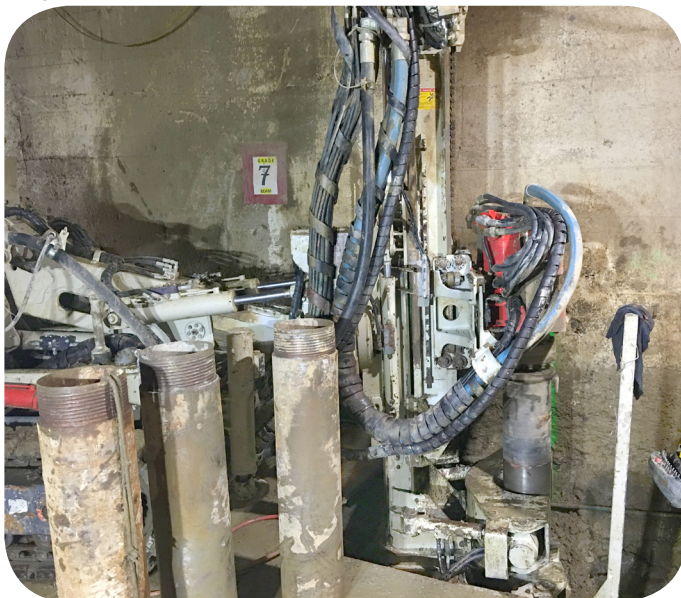
**Retractable casing being installed through the overburden**

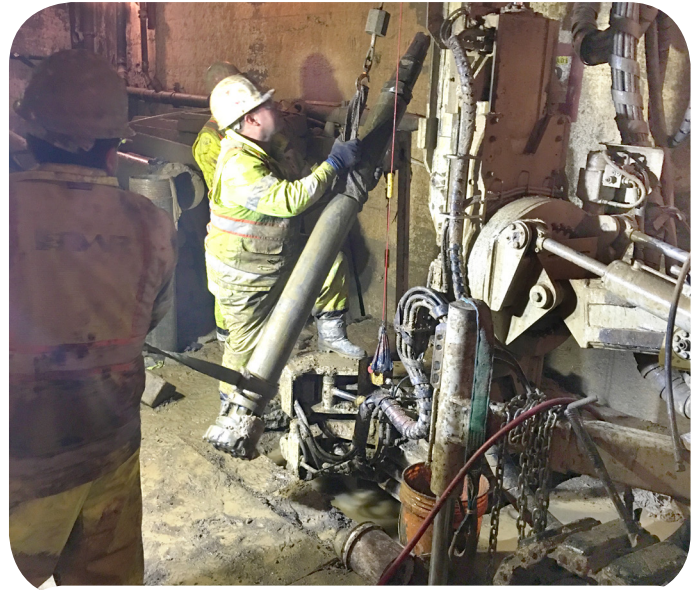
**DTH hammer being pulled out of hole after drilling to 60ft**

The bedrock consisted of layered shale and sandstone but the sandstone layers were much weaker than expected, which necessitated a recalculation of the overall shear strength and the bond lengths being deepened. This caused pile lengths to be increased to up to 60ft.

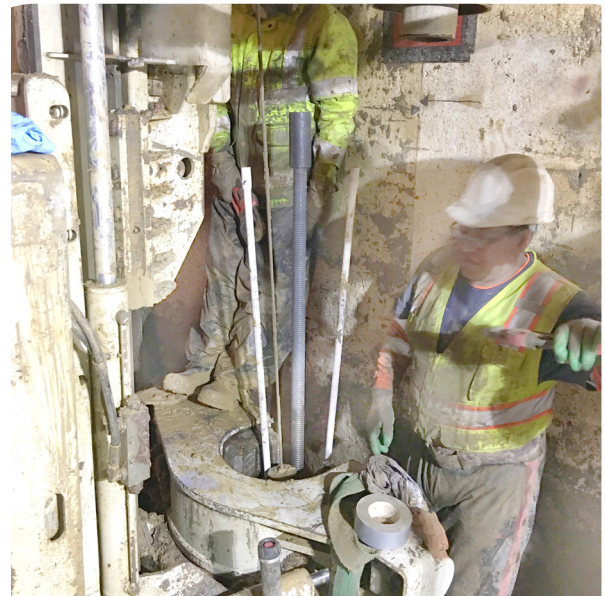
**Lowering reinforcing rod with 2 postgrout tubes into hole**

After reviewing the soils data, RWR decided to use a rotary percussion drilling technique to install 8" diameter micropiles reinforced with a solid 1 3/8" diameter 150KSI bar.

As an added precaution, all piles were post grouted 24 hours after installation. Tension testing was performed on 20% of the piles to 133% of the design load of 75 kips and all passed.
