Landslide In San Rafael Endangered Homes

The Challenge

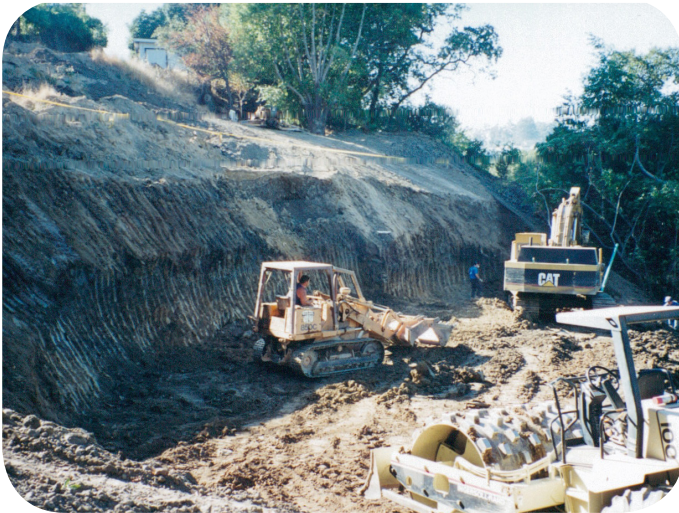
Working our way up the hill, excavating a bench into competent material

Action: The repair called for removal of the slide material, benching into competent bedrock and re-installation of the slide material in compacted lifts.

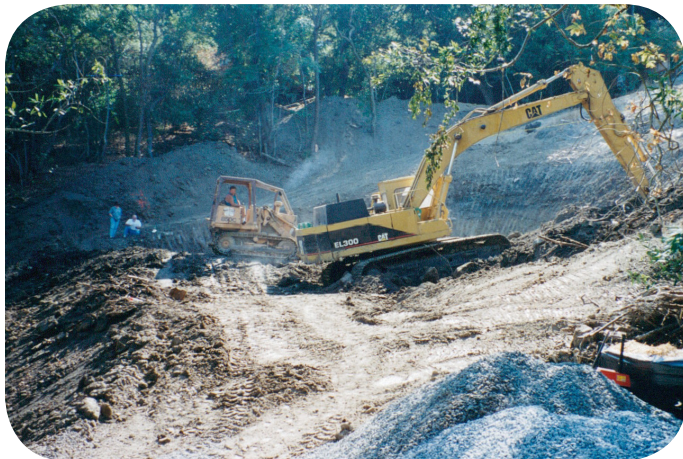
Excavating out unstable soils

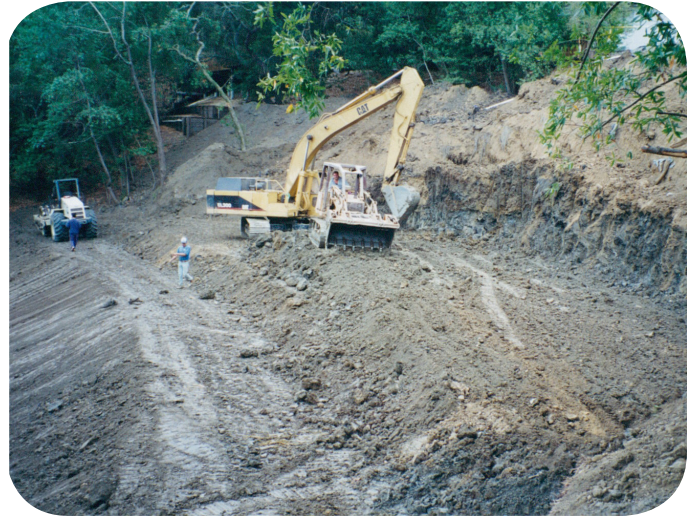
Spreading out slide material in 8" lifts

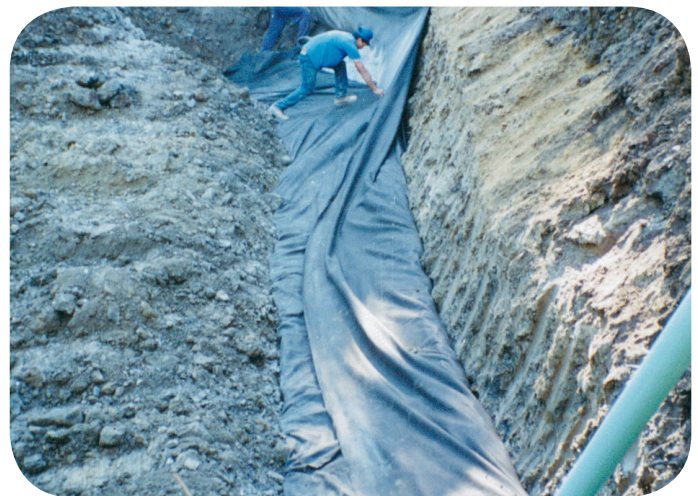
Wrapping a sub-drain at the back of a bench, in filter fabric

A series of sub-surface drains were placed at the back of the benches.

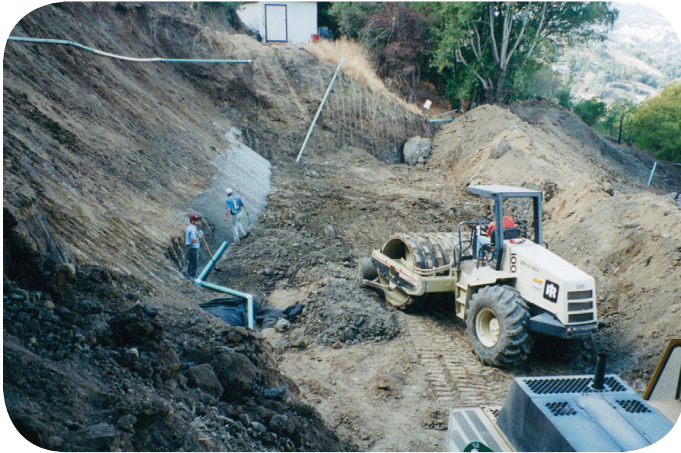
Drain pipe and sub-drain installation,
with sheep-foot compactor in foreground

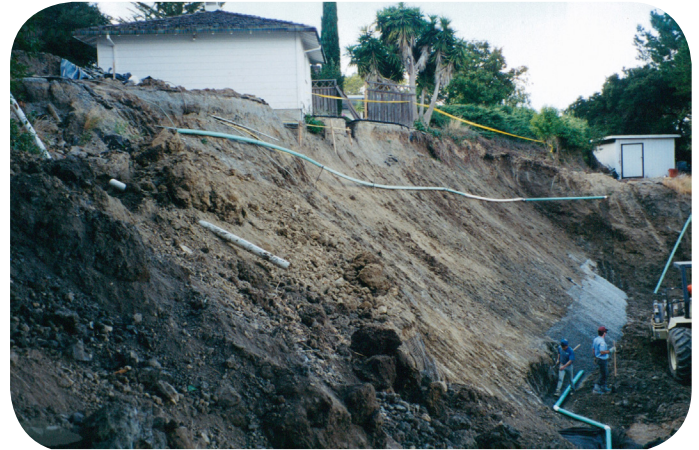
Endangered structure at top of landslide.

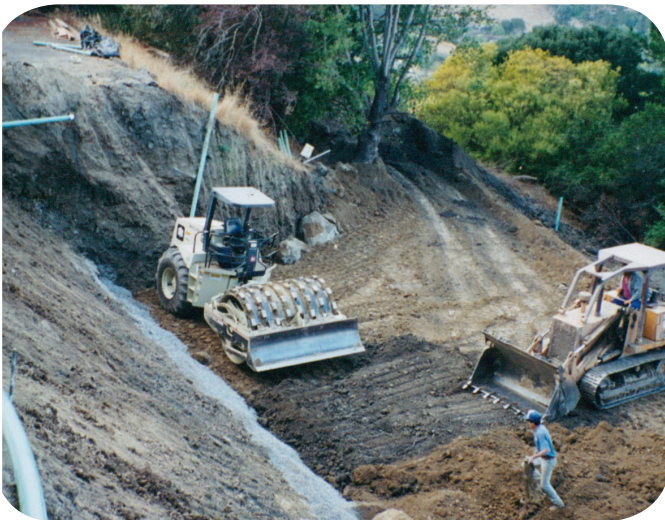
Compacting slide material with sheep-foot roller.
Top of sub-drain gravel showing.

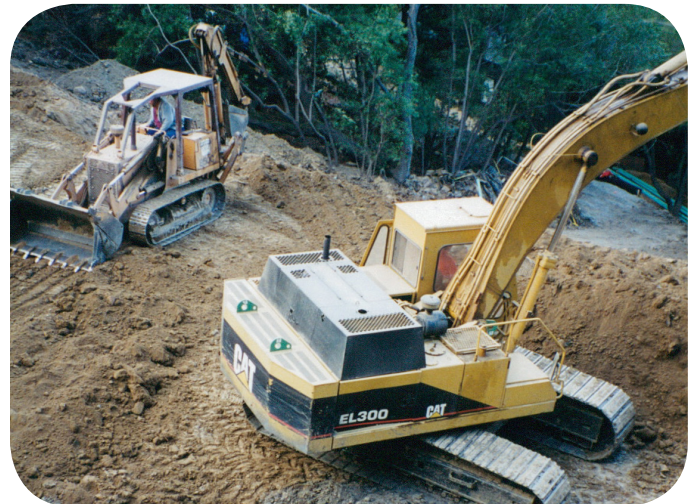
Sitting on compacted bench

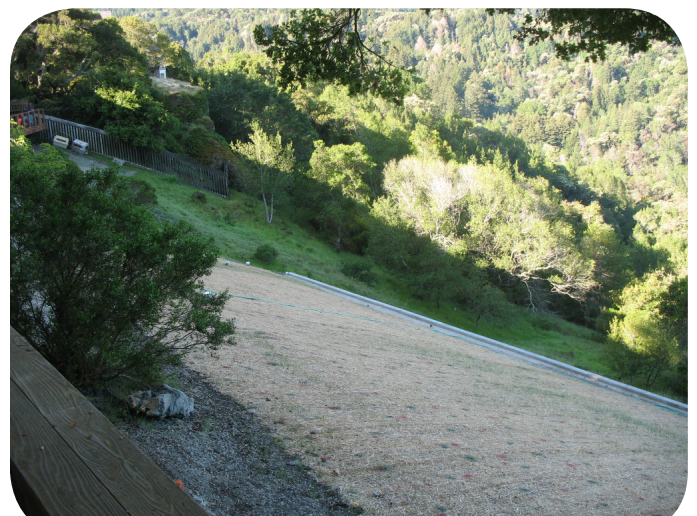
Finished slide repair. Hillside re-seeded
and erosion protection matting installed.

Surface improvements were also installed, including concrete V-ditches and drop inlets to channel rain-water away from the slope. Finally, re-vegetation with perennial rye-grass was installed along with surface erosion protection using jute netting, allowing the grasses to take hold.

Results: This neighborhood is now safe, with the full value of the properties restored. The slide repair has been through many heavy winters with no sign of any further movement or distress.
