Failing Retaining Wall Endangered Residence

The Challenge

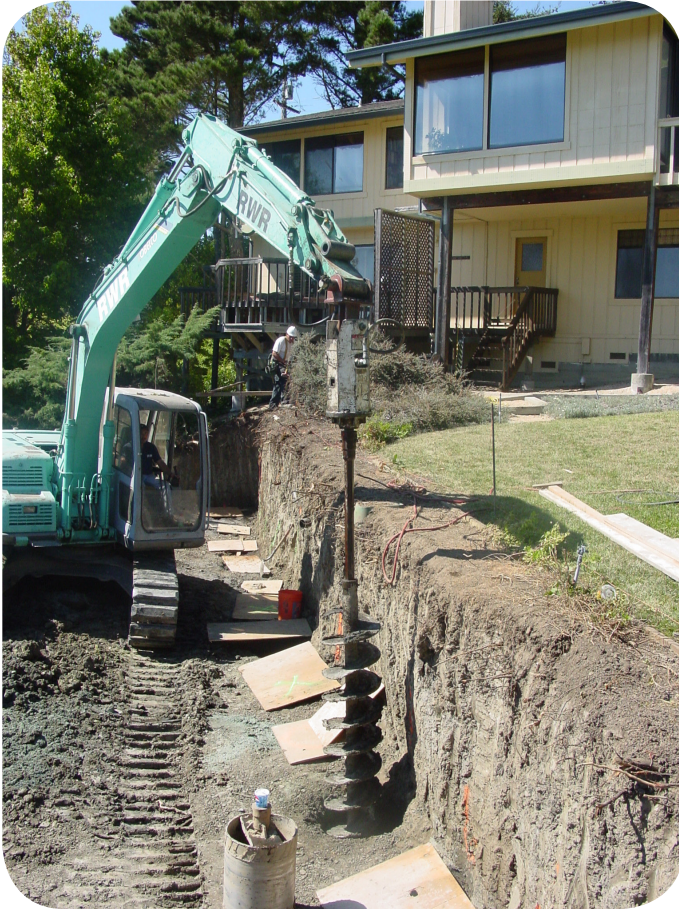
Track Drilling For Soldier Beams

The repair consisted of installing a soldier beam wall with tiebacks at the rear of the property. Piers were drilled down through the slide and into bedrock. Steel beams were then placed in the piers and filled with concrete. The top 6ft. portion of the slide was restrained with pressure treated wood placed between the beams. Tiebacks were also installed near the top of the beams. The portion of the slide below grade was halted by a bridging effect between the steel beams.

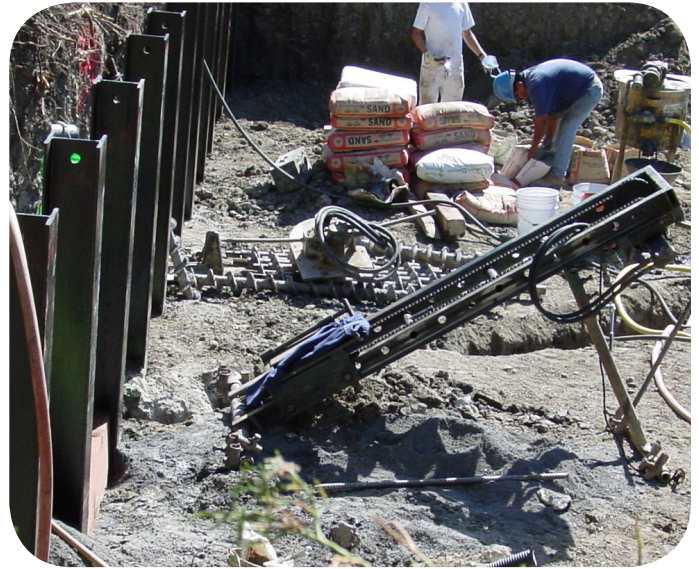
Small tieback rig frame

The Tiebacks were necessary because the beams needed to be restrained at both the top and bottom in order to resist the slide forces.

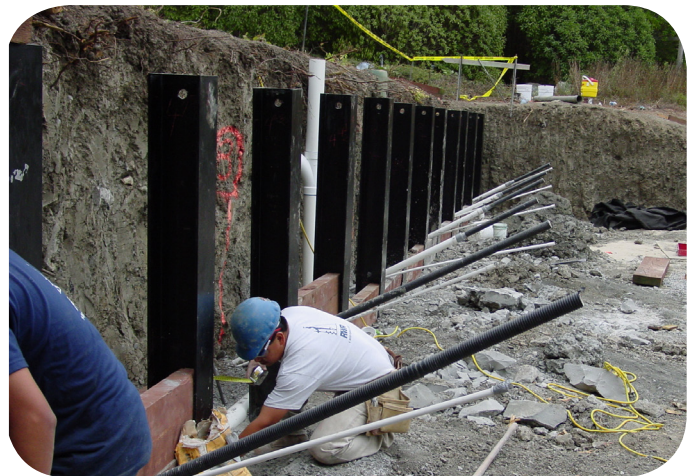
Soldier beam steel and double corrosion protected tiebacks with post-grout tubes.

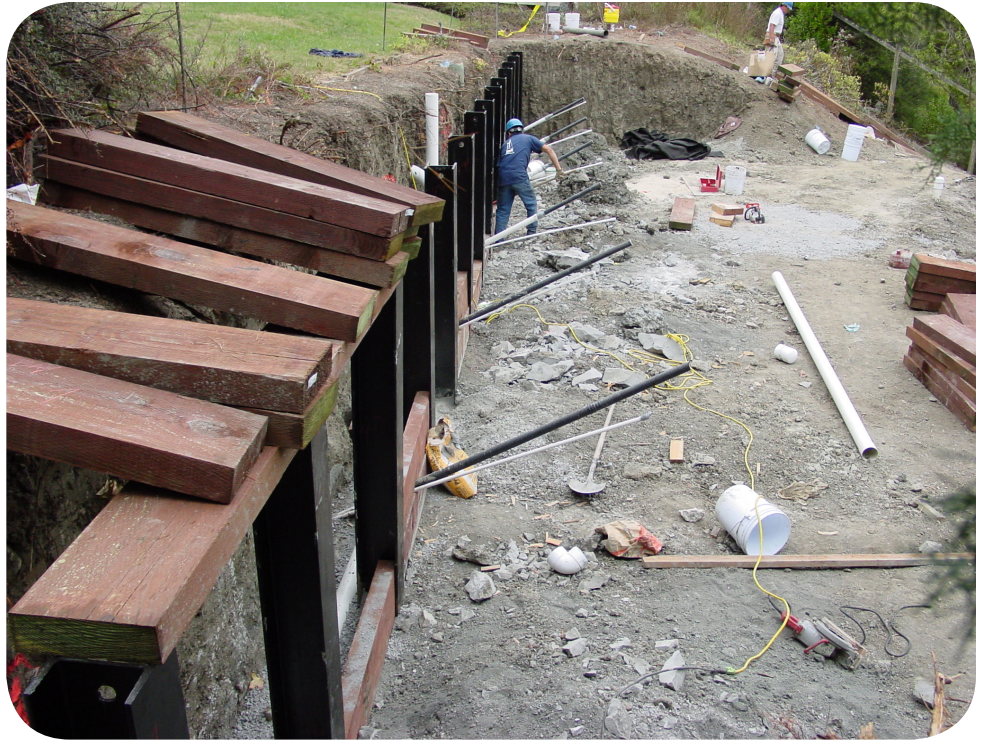
Cut-to-size pressure-treated lagging starting to be installed

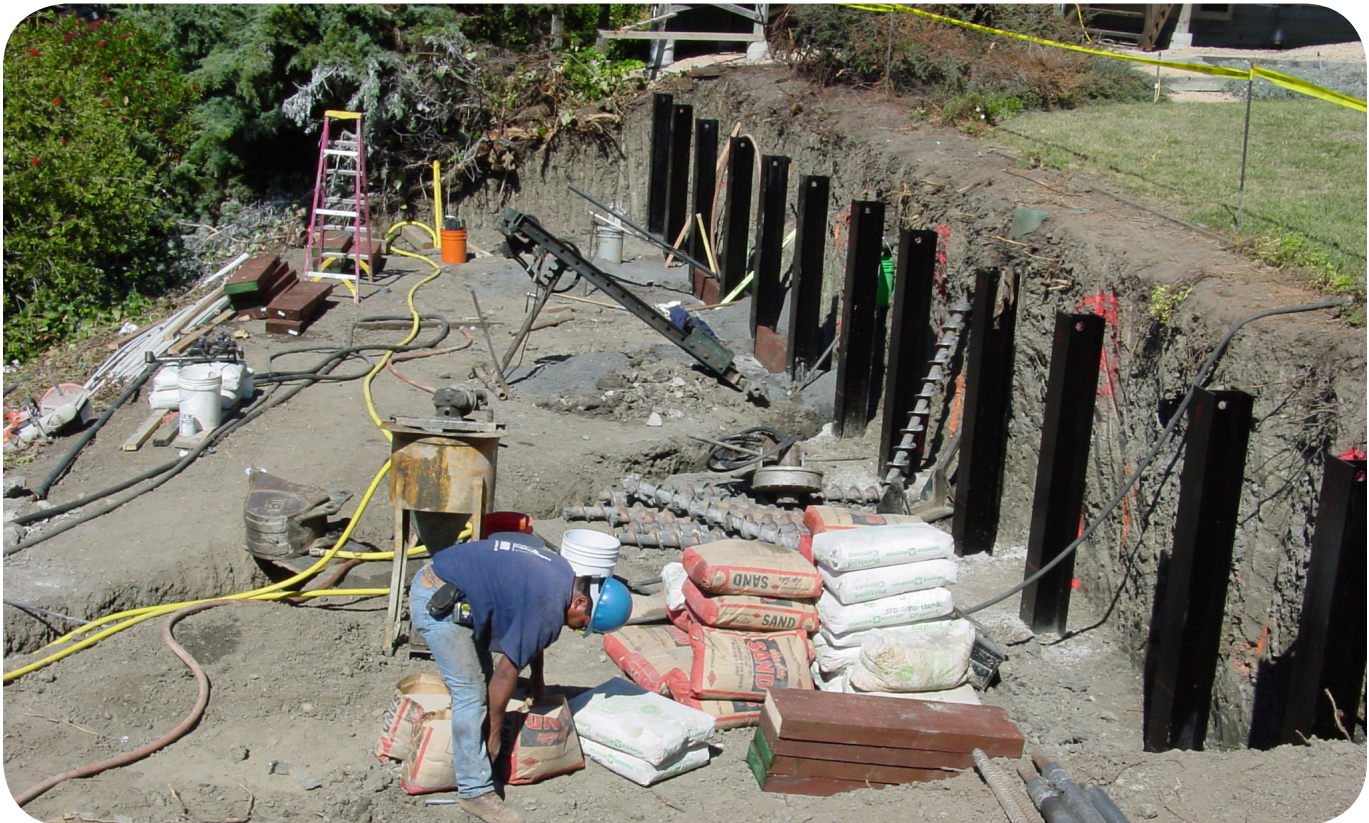
Grouting tiebacks with grout hopper in background
