# Deep Micropile Installation Under Existing Multistory Building

## Case Study

The Owners of a former warehouse located in the vibrant tech start-up area south of Market St. in San Francisco made the decision to bring the building up to current earthquake standards and to have the option to add on another 3 stories.

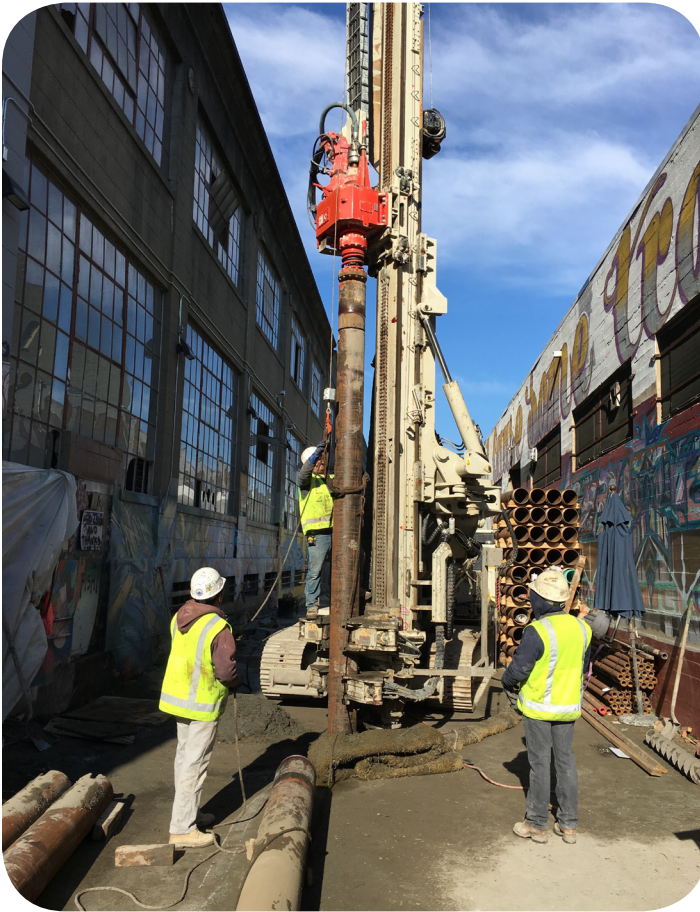
**Installing Casing Driver On Drill Rig**

In order for the piles to have the necessary resistance to lateral earthquake forces, the top 13 ft. of all the piles were reinforced by first installing 10" diameter x ½" thick steel casing, then injection drilling through the casings. Footing trenches were already excavated in the basement so the casing was installed 13 ft. below the bottom of excavation. But the exterior was 11 ft. above bottom of footing, so a casing driver was

constructed and used to insert the top of the 13 ft. long exterior casing to the proper depth. Disposable plastic piping was then inserted that reached from grade into the top of the steel casing to prevent collapsing and guide the drill bars into the casing.

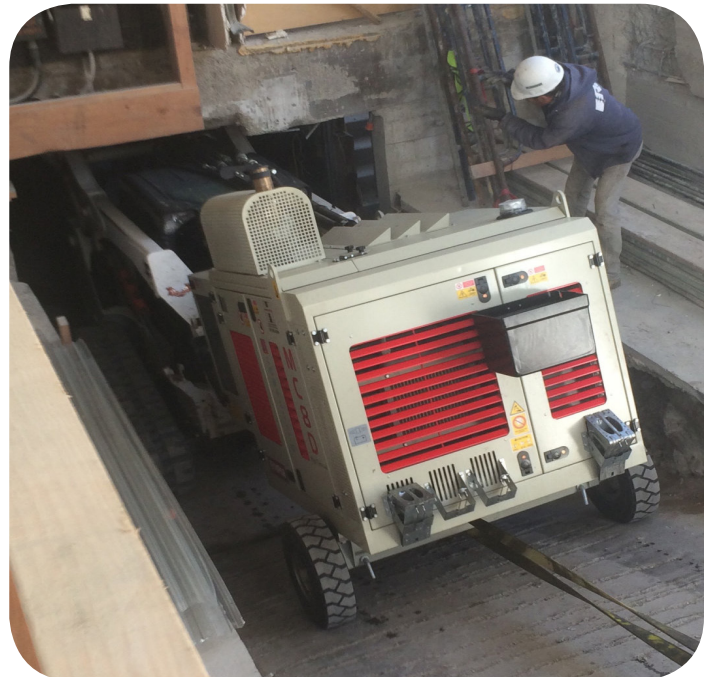
**Bringing A Drill Rig Into The Basement**

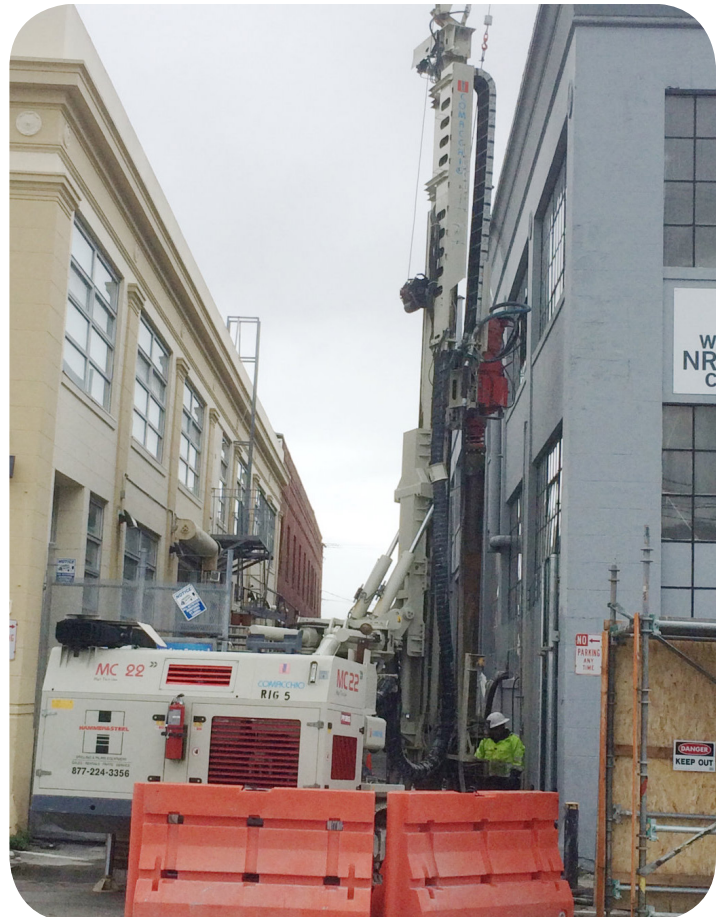
**Limited Access: Installing Micropile  
At Perimeter Of Building**

The perimeter micropiles were installed with a 45,000 lb. rotary drilling rig plumbed for continuous injection. The interior piles were installed with 18,000 lb. drill rigs similarly plumbed.

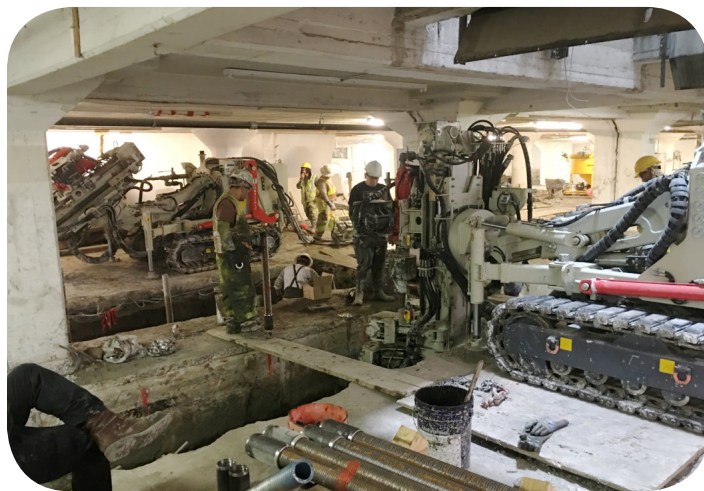
**Two 18k Drill Rigs In The Basement**

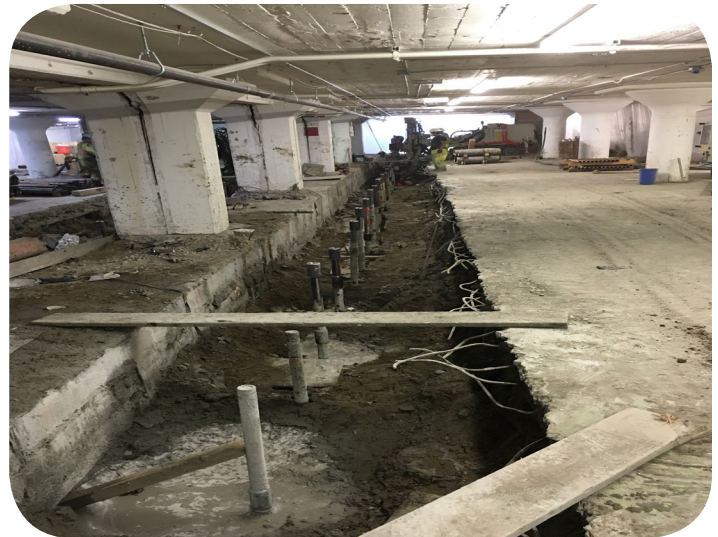
**Tops Of Micropiles Visible In Trenches**

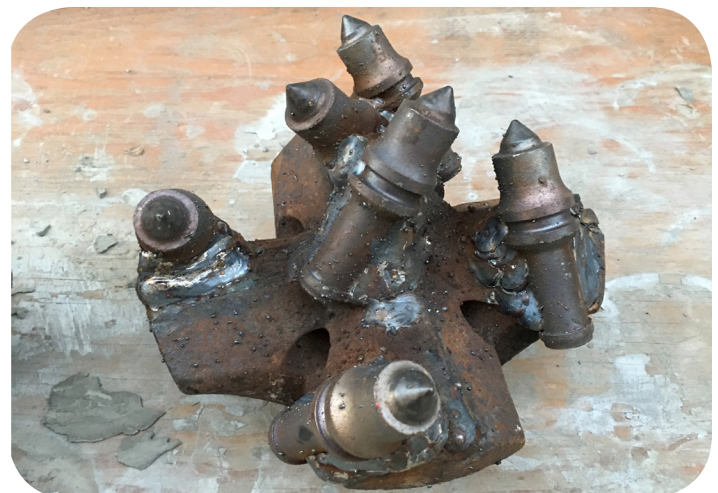
**Crossbit Customized In RWR Welding Shop,  
To Penetrate Extremely Hard Bedrock**

Since the soil borings had stopped at the top of the bedrock, it was discovered during installation of the test piles that the bedrock was of extreme hardness. Even with 30,000 lbs. of down pressure the rock could only be penetrated to approximately 3-5 ft. with the ported carbide tipped cross bits that were standard for

rock drilling with the hollow bars. Rotary percussion was ruled out because the impact energy would mostly be lost through the extreme depths of the muds. The bits were taken to RWR's welding shop and after pre-heating, conical carbide tipped drill teeth were welded on to the cross bits. This adaptation allowed penetration through the bedrock to the necessary depths.

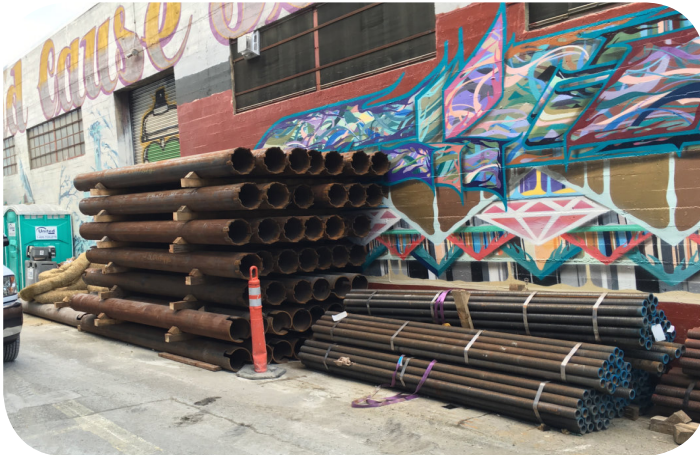
**Casing And Hollow Bars For Exterior Installation**

The exterior micropiles were installed using 3" diameter hollow drill bars in 3 meter lengths. Due to the 8 ft. headroom, the casings in the basement were threaded and installed in 1 meter lengths and the bars in 1 meter lengths as well. All bars were connected using couplers with special metal seals that could withstand the up to 600psi grout pressures.

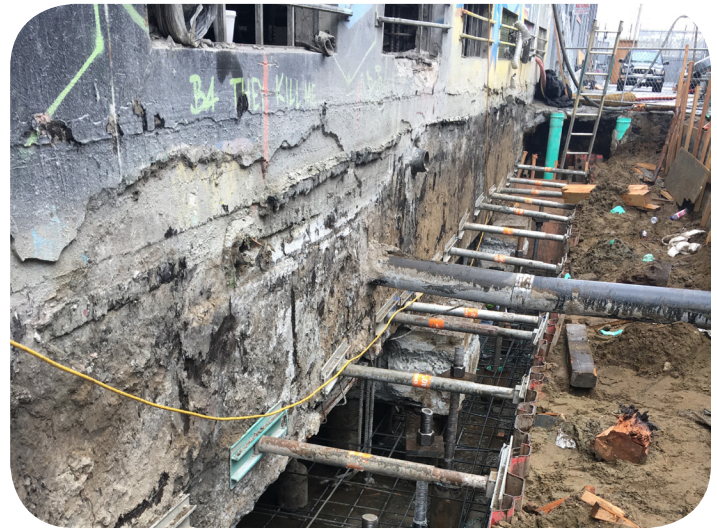
**Exterior: Top Of Micropile With Bearing Plate & Nuts  
Visible Along With Plastic Sleeving At Far End**

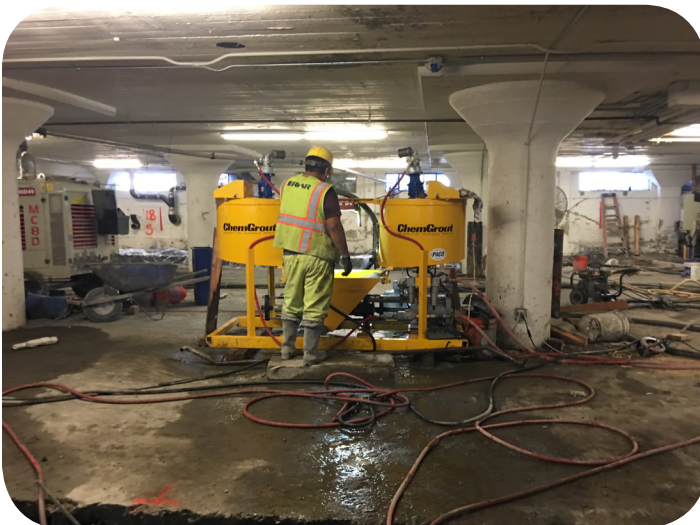
**2nd Grout Pump In Basement**

Due to the tight schedule, there were 2 low overhead rigs and crews operating inside, 1 rig and crew outside and a grout plant with crew. The grout plant was modified to be able to pump grout to 2 machines at once: a Y valve was installed that would direct the batched grout to either the high pressure pump on the grout plant or to a double-hopper grout plant in the basement that fed a 2nd machine. A dance of casing installation and injection grouting between the 3 rigs required constant oversight and careful scheduling. Up to 20 tons of cement were delivered in a double hopper truck every-other morning and blown into the silo to feed the grout plant. The grout, which consisted of neat cement and a retarder to allow for the hard rock drilling time, had a specified strength of 8000psi. There was continuous

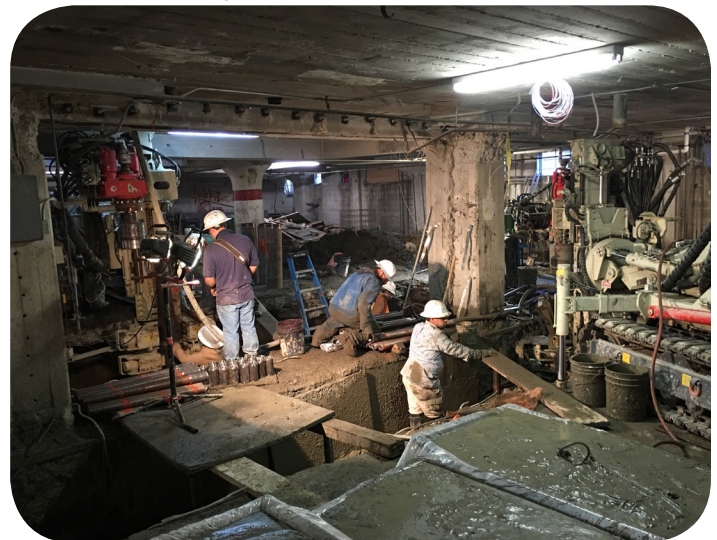
**2 Drill Rigs Working Opposite Trenches**

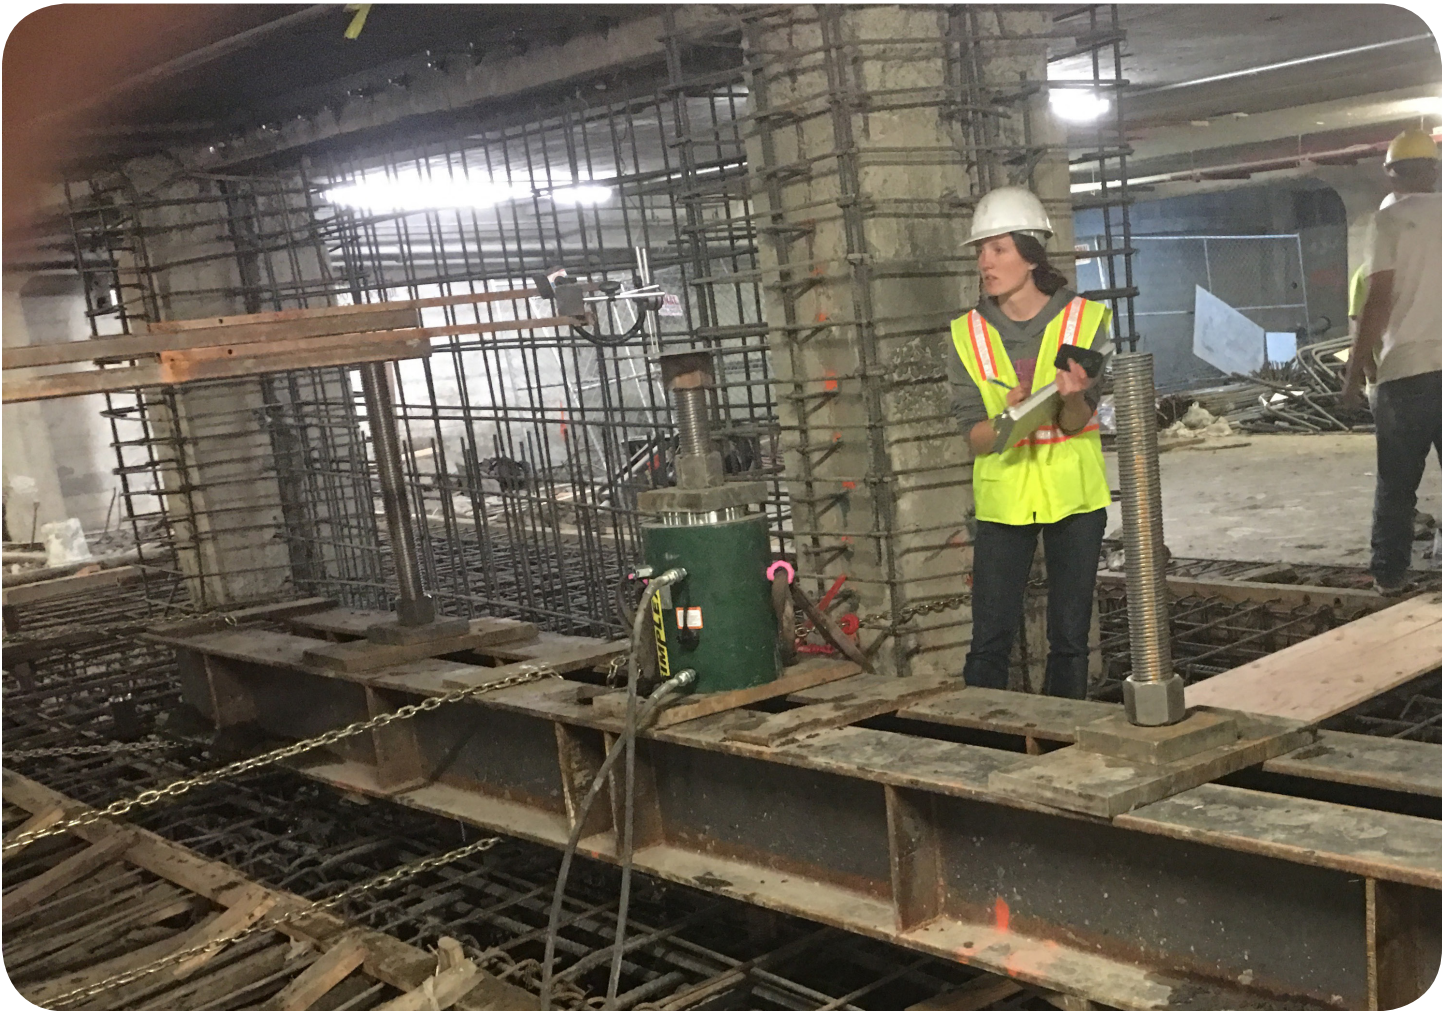
**Production Micropile Testing Using Adjacent Piles As Reactions  
And To Suspend Testing Frame Over Footing Reinforcement**

Three initial compression tests were performed to verify the loading requirements. 20% of all production piles were pull tested to 133% of compression design loads, which also verified tension load requirements.

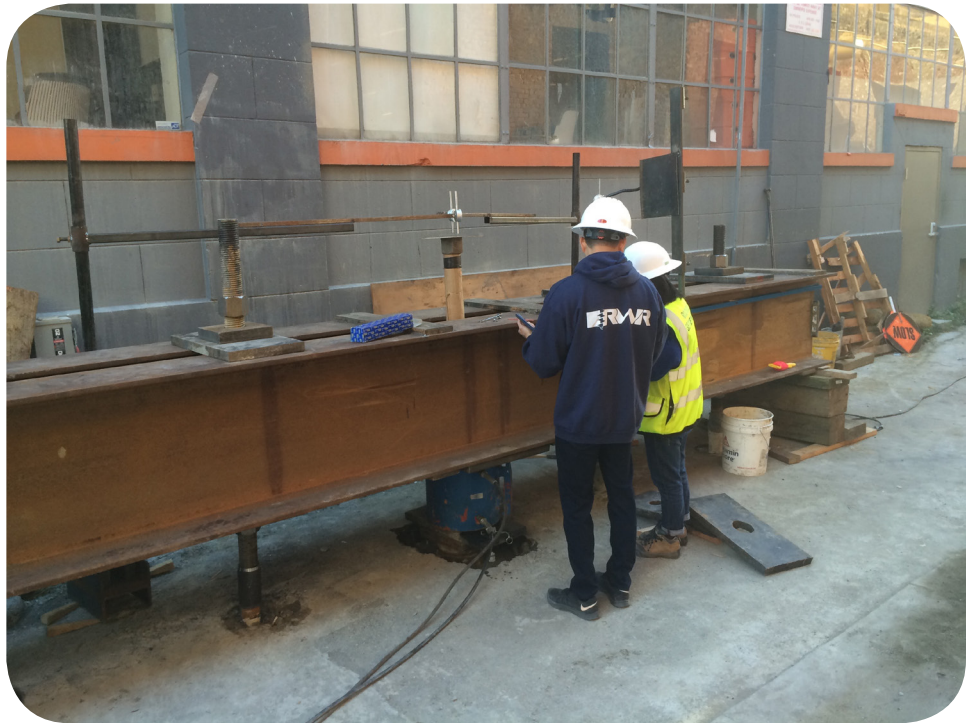
Compression Test On Sacrificial Pile, Using Production Piles As Reactions. Failure Occurred At 350 kips
