Failing Retaining Wall Endangered Residence

The Challenge

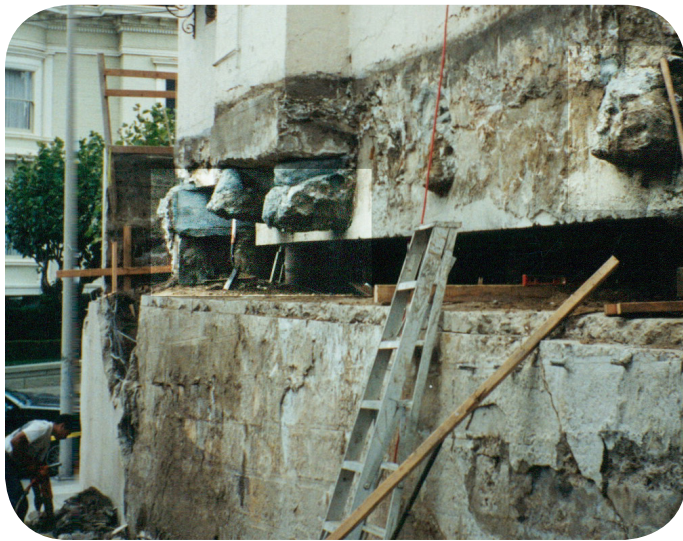
Closeup of underpinned foundation showing ends of earth-cast cantilevered beams projecting through foundation.

Since the wall could not be removed without first supporting the house, a system of drilled piers with grade beams was installed under the house and extended beneath the exterior foundation and fireplace. These cantilevered beams supported the house while the retaining wall was demolished and replaced with a new shotcrete wall. After the structural work was complete, the wall was stuccoed and painted and the landscaping was replaced.

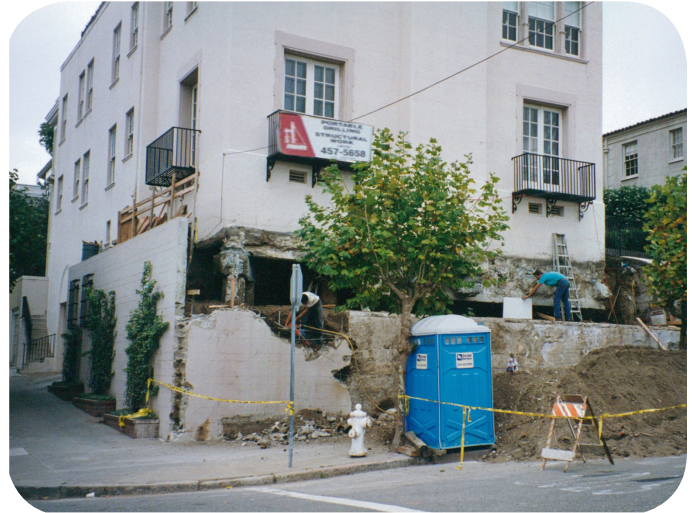
Underpinned house with top of old retaining wall removed

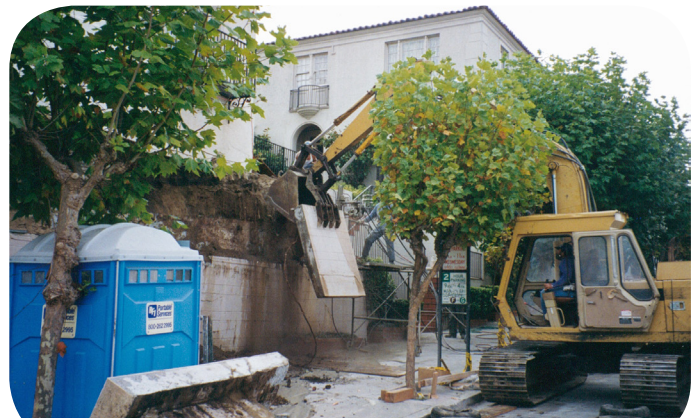
Removing failed retaining wall

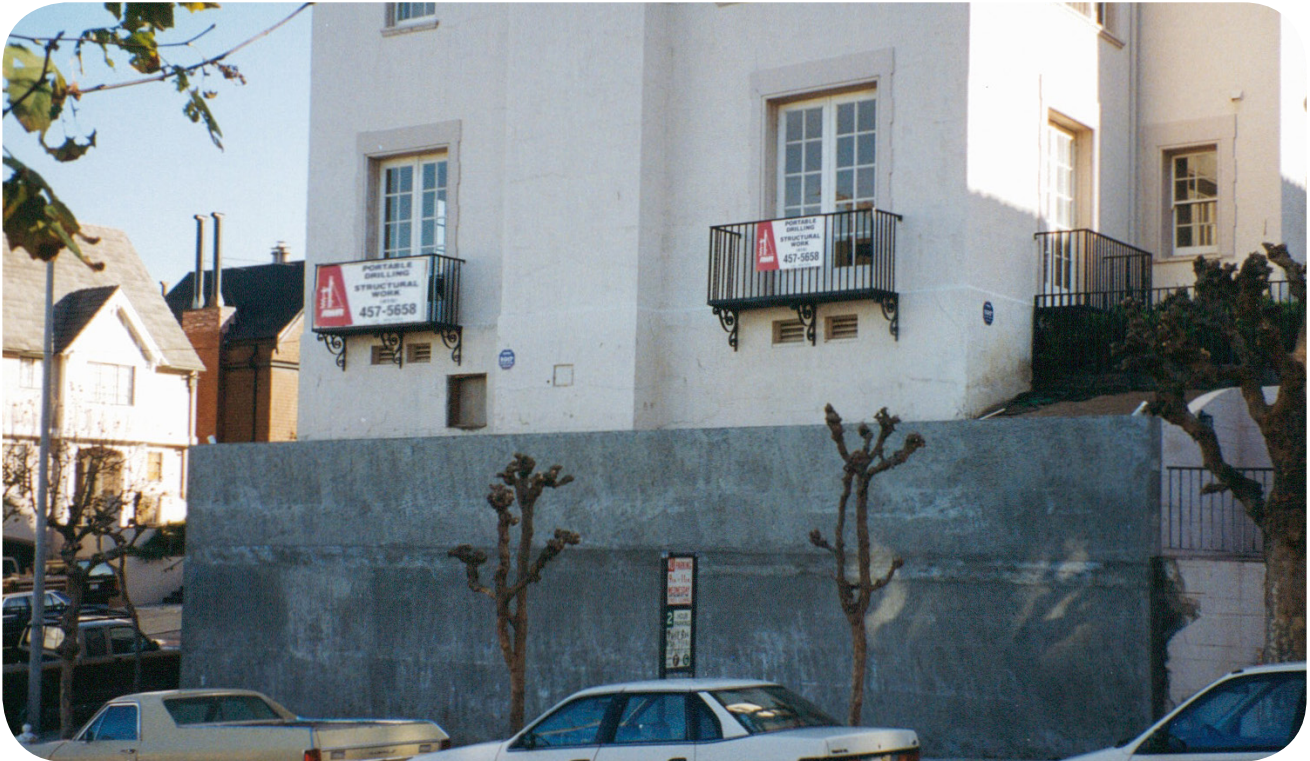
Shotcrete wall ready for finish work

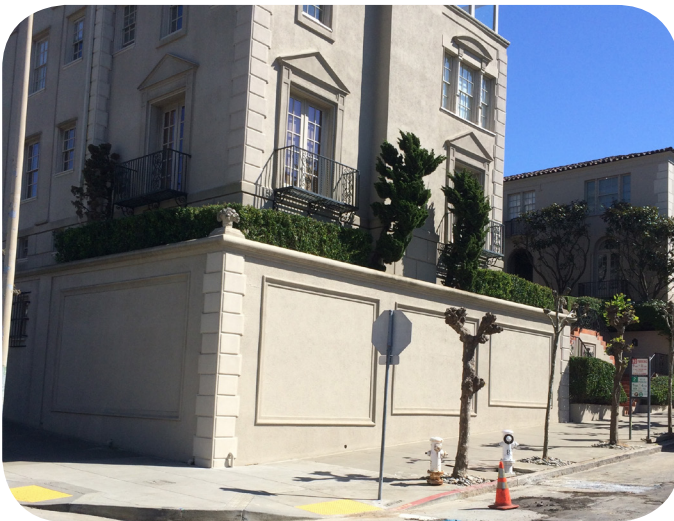
Finished wall with house secured

The house sits on the corner of Walnut St. doubly supported by the cantilevered shoring system left in place and the new retaining wall. Safety and property values have been fully restored and the residence is an enhancement to the neighborhood.

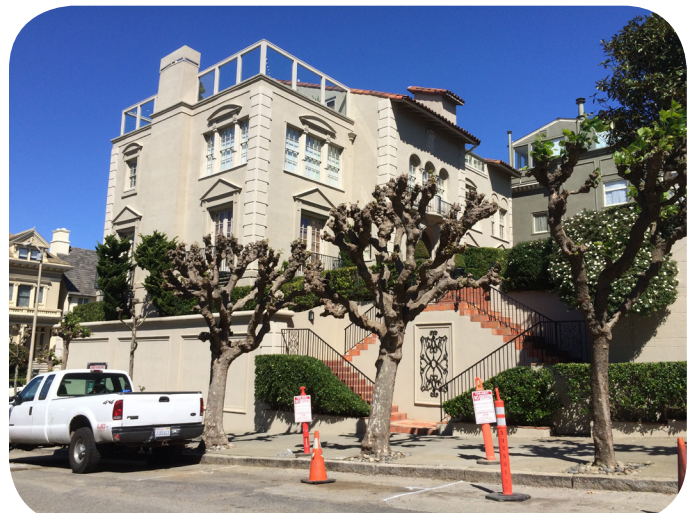
The final result
